PASSAIC RIVER BASIN
TRIBUTARY TO LUBBERS RUN BROOK
SUSSEX COUNTY
NEW JERSEY

JOHNSON LAKE DAM

NJ 00499

PHASE 1 INSPECTION REPORT NATIONAL DAM SAFETY PROGRAM

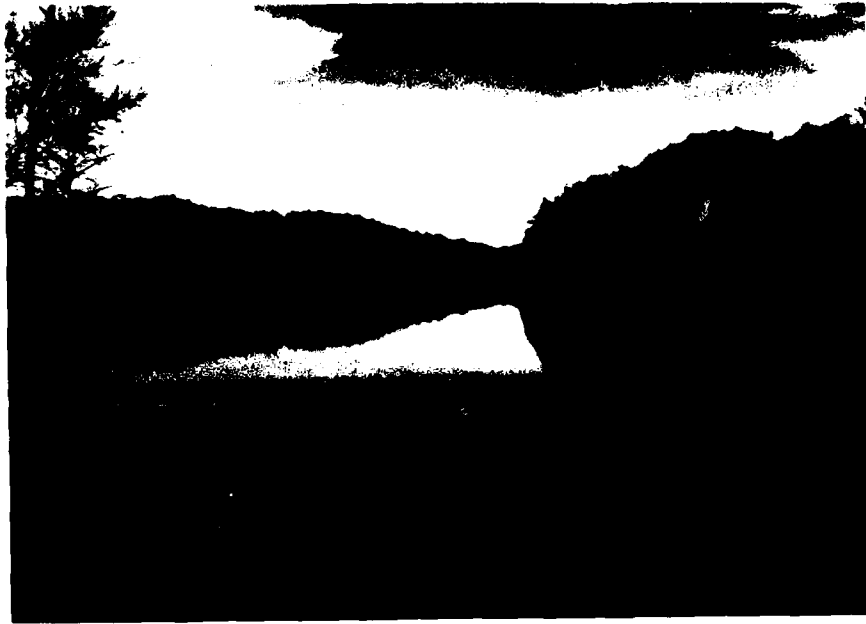
NOV 1979
View of the upstream reservoir from spillway
crest.
